LOCHMERE DAM

NH 00015

PHASE I INSPECTION REPORT  
NATIONAL DAM INSPECTION PROGRAM

12. REPORT DATE November 1978		13. NUMBER OF PAGES 45
14. MONITORING AGENCY NAME & ADDRESS (if different from Controlling Office)		15. SECURITY CLASS. (of this report)  UNCLASSIFIED
		15a. DECLASSIFICATION/DOWNGRADING SCHEDULE

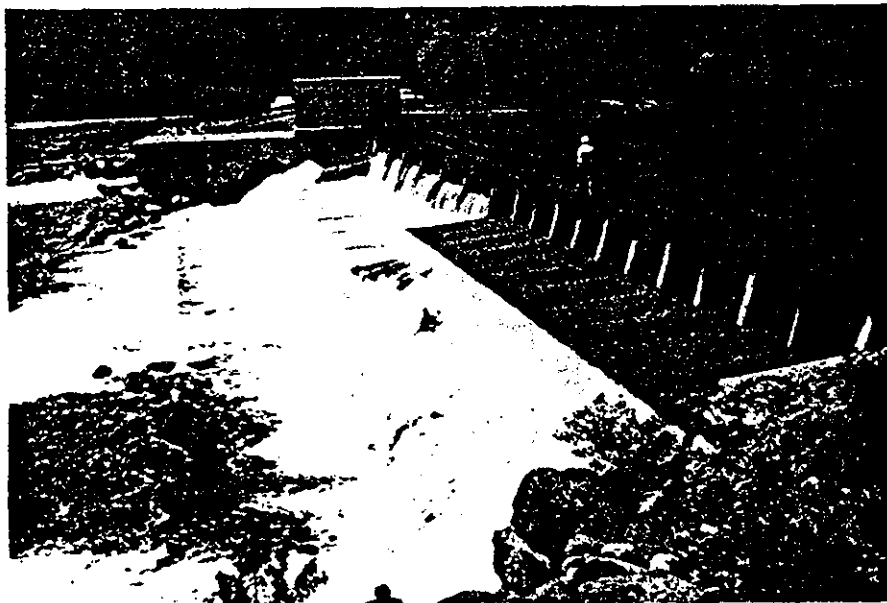
Overview from left abutment

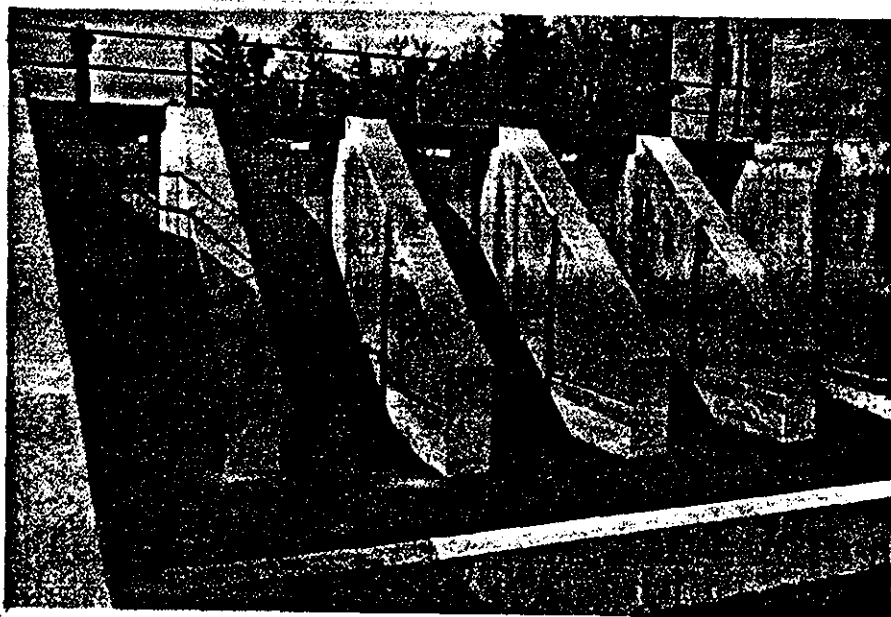
1. View from downstream of right side gate structure

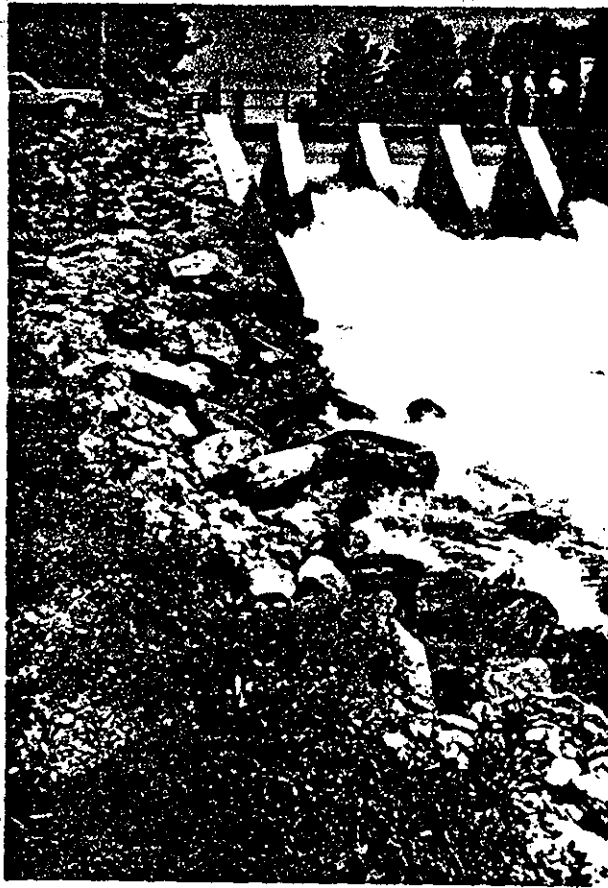
3. View from downstream of repairs to eroded area near toe of right side outlet channel
